ISUZU

BULLETIN

BULLETIN NUMBER:
SB03-05-S001

DTC P1870 AND THE 4L30E AUTOMATIC TRANSMISSION (THIS BULLETIN SUPERSEDES BULLETIN SB02-05-S003)

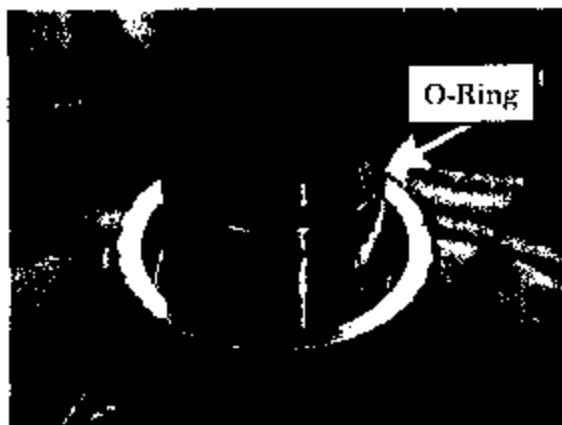
Figure 1

9. Remove the turbine shaft o-ring and discard it (see figure 1).

62. Install a new turbine shaft o-ring (8-96013-953-0). Lube it with DEXRON®-III with a G-License Number (G-XXXX) (*refer to bulletin HB03-05-S001 4L30E/4L60E Transmission Fluid*).

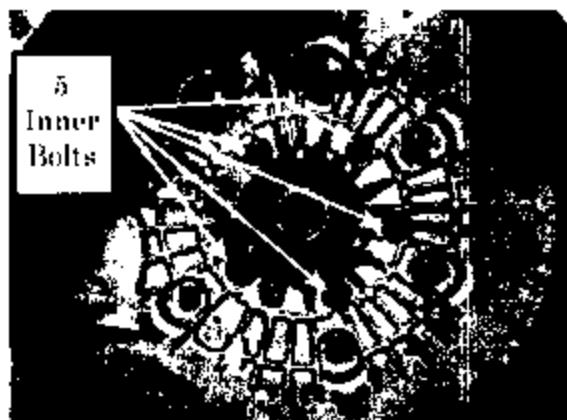
Figure 2

10. Remove the seven case housing bolts at the outer ring, *not the 5 inner bolts* (see figure 2).

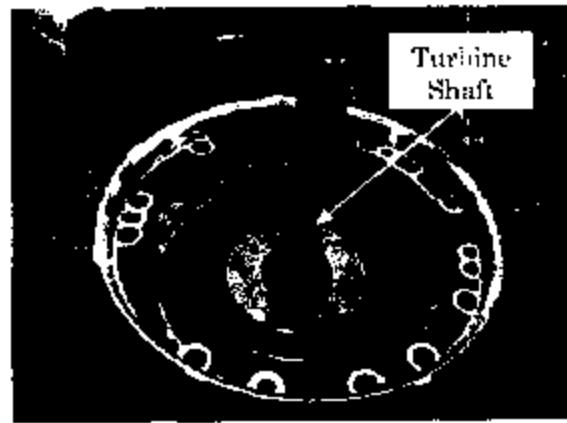
Figure 7

18. Grab the turbine shaft and lift out the 4th clutch, 4th retainer, & overrun assembly (see figure 7).

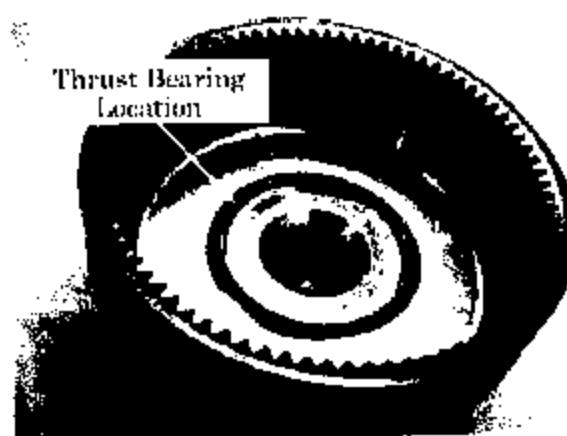
Figure 9

20. Remove the overdrive internal gear and thrust bearing (*see figure 9*).

49. Reinstall the overdrive internal gear and thrust bearing. DEXRON®-III with a G-License Number (G-XXXX) (refer to bulletin IB03-05-S001 4L30E/4L60E Transmission Fluid) (see figure 9).

NOTE: Thrust bearing outer case faces the internal gear.

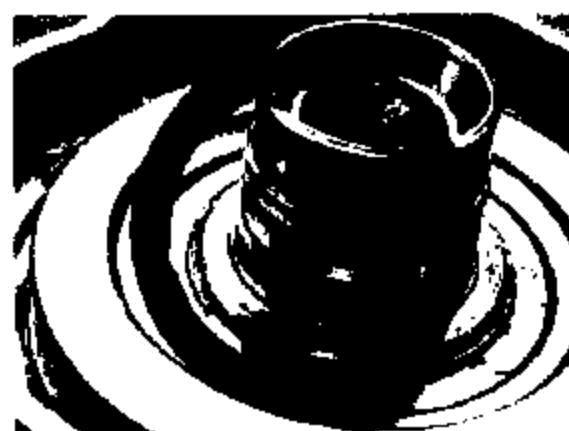
Figure 11

23. Remove the selective washer from the center support housing (*see figure 11*).

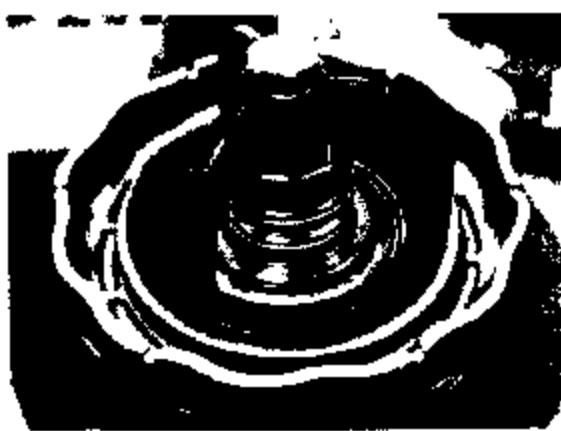
Figure 13

26. Compress the reverse spring seat with Special Tool P/N J-23327 (Reverse Spring Seat Compressor) (*see figure 13*).

41. Install the new spring seat (8-05258-021-0) and compress the springs with the compressor. Special Tool P/N J-23327 (Reverse Spring Seat Compressor) (see figure 13).

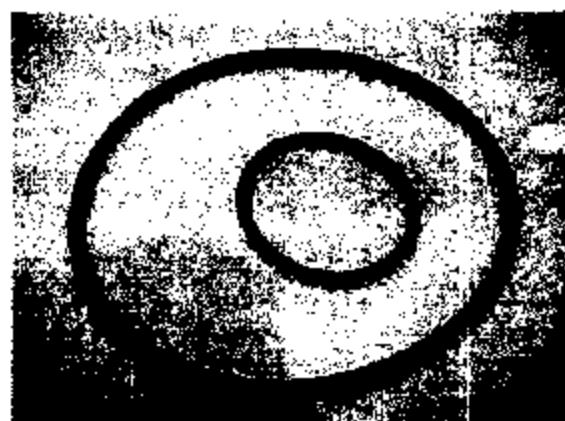
Figure 15

29. Remove the reverse piston. Discard the inner & outer o-rings (*see figure 15*).

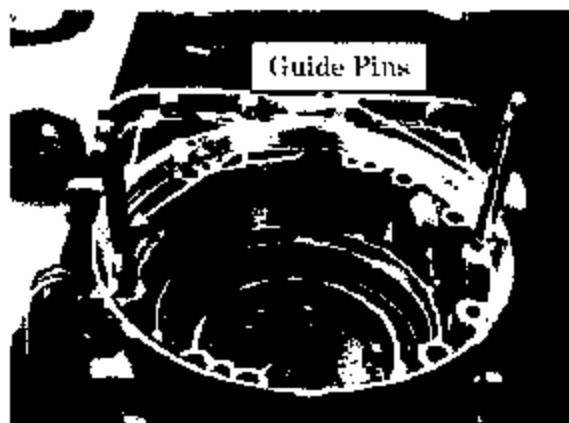
Figure 22

45. Install the two 9 inch guide pins. Special Tool P/N J-38588 (see figure 22).

59. Remove the two 9 inch guide pins (*see figure 22*).

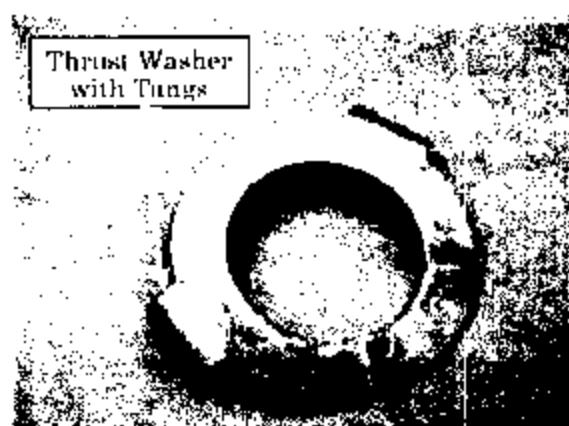
Figure 23

47. Reinstall the thrust washer, tangs toward the adapter case in their slots (see figure 23).
